Rear axle bush for wheel bearing housing

to fit
Mercedes-Benz C Class (202, 203 and 204),
E Class (207, 211 and 212), S Class (221) and
other models

SWAG No. 10 92 1174
Repl. no. 204 352 00 27

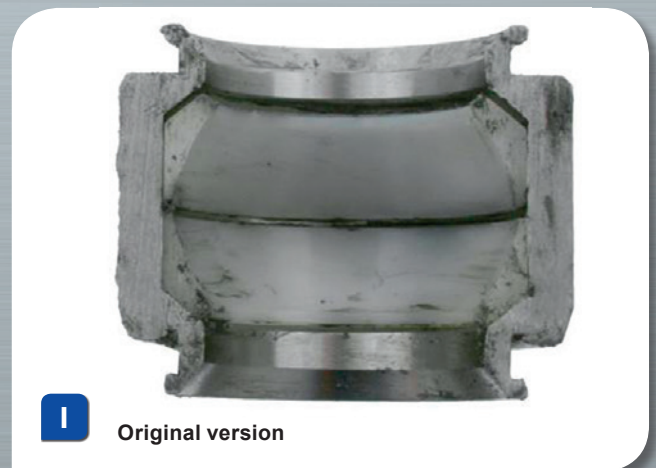
1 Original version

Due to its design, the rear axle bush is shortened by poor road and weather conditions. The version originally fitted (Repl. no. 201 352 00 27) has a lubrication channel in the inner plastic tray (see Fig. 1). However, this is not always sufficient to lubricate the joint evenly. The drying out that is sometimes associated with this makes the joint susceptible to wear. Mercedes-Benz has withdrawn this version from service and replaced it.
